**SITE INVESTIGATION
SIXTY MINUTE CLEANERS
ROCK HILL, SOUTH CAROLINA
YORK COUNTY
SCS 123 457 884**

**U.S. ENVIRONMENTAL PROTECTION AGENCY
Region 4
61 Forsyth Street
Atlanta, Georgia 30303**

**South Carolina Department of Health and Environmental and Control (SCDHEC)
Division of Site Assessment and Remediation
Federal & State Site Assessment Section
2600 Bull Street
Columbia, South Carolina 29201**

December 8, 2020

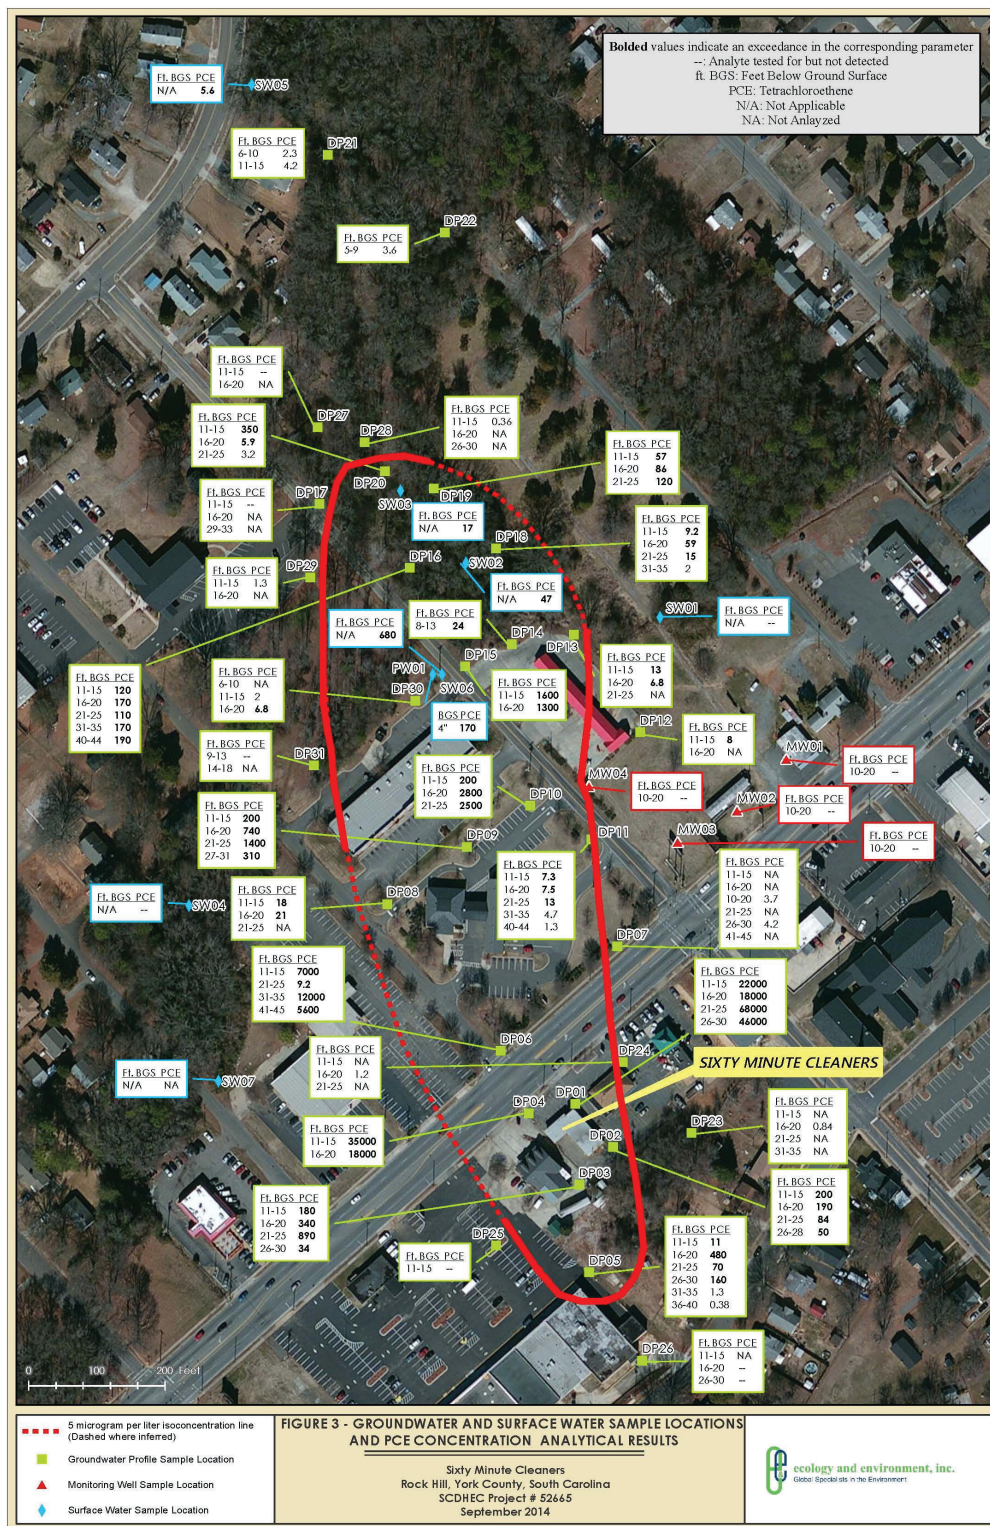
Figure 3
Groundwater and Surface Water Locations w/ PCE Concentrations
Sixty Minute Cleaners, Rock Hill, SC

A data report submitted to SCDHEC by Ecology & Environment dated July 29, 2016 showed the presence of a widespread groundwater plume originating at the Sixty Minute Cleaners site and extending approximately 1300 ft north-northwest with a width of approximately 350 ft (Figure 3). The report also verified the presence of chlorinated solvent contamination in the downgradient surface water body sampled in the previous investigation (Figure 3) (Reference #7)

Based on data collected from this investigation and previous investigations conducted at the site, depth to groundwater in the surficial aquifer across the horizontal extent of the known groundwater contamination plume is roughly 10-15 ft bgs. Based on general topography of the landscape and the dispersion of chlorinated solvents from the source at the former Sixty Minute Cleaners to the furthest downgradient areas of the plume, groundwater flows in a north-northeast direction towards the intermittent stream located west and north of the Wal-Mart Neighborhood Market property boundary (Appendix C) (Figure 3) (Figure 4).

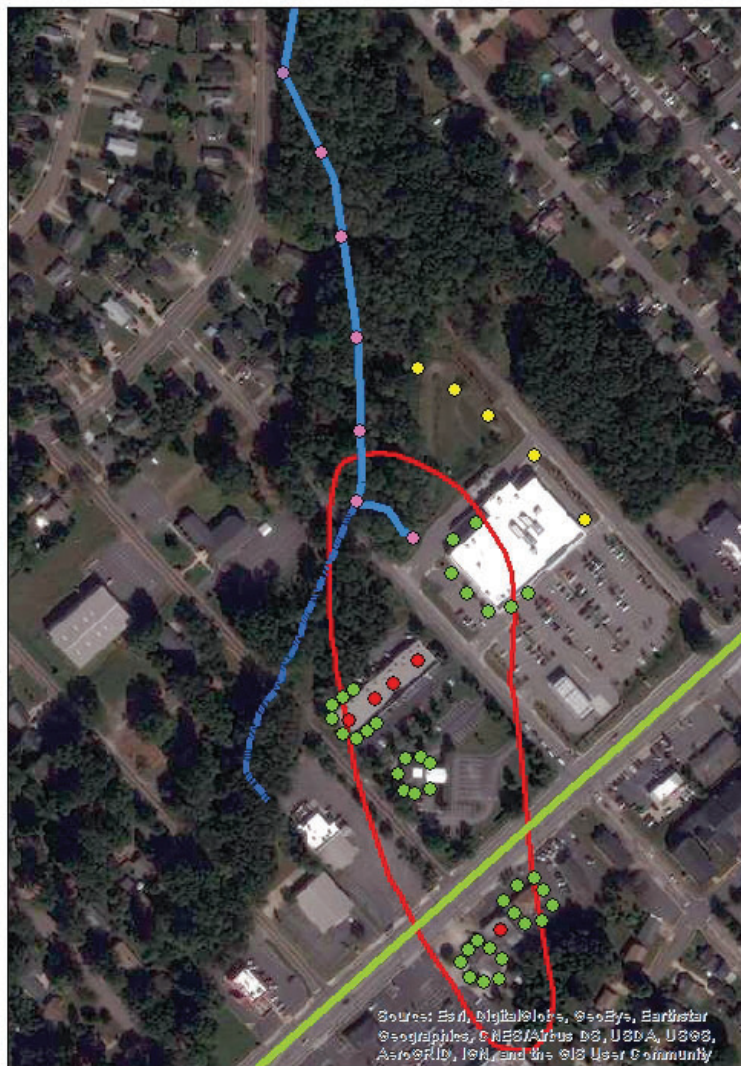
Figure 4
Sampling Locations
Site Investigation
Sixty Minute Cleaners
Rock Hill, SC

Potential sources areas at the site include the former Sixty Minute Cleaners property. A large groundwater plume originates at the property and extends approximately 1,300 ft. north-northwest from the site and is approximately 350 ft. wide. However, the full horizontal extent of the plume was not delineated prior to this report. Two profile locations (DP18 and DP19) near the northeast corner of the plume show MCL exceedances extending to depths between 11 and 25 ft below ground surface (bgs) (Figure 3) (Reference #7). Due to issues during prior investigations obtaining property access to certain parcels, there were no additional profile locations beyond this edge of the plume heading in a northeast direction. This SI attempted to fully delineate the extent of the groundwater plume (Reference #9) (Figure 4).

The data report submitted on July 29, 2016 showed that chlorinated solvents were present in a stream located west and north-northeast of the known groundwater plume associated with the site. Multiple samples were collected from the stream, but the furthest downgradient sample still contained chlorinated solvents (Reference #7). This SI attempted to fully delineate the extent of chlorinated solvents in the surface water pathway (Figure 4).

In addition, this SI attempted to determine the horizontal extent of any soil gas plume associated with the known groundwater plume. The use of in-situ Beacon® samplers was employed to accomplish this task. Thirty (38) sampling locations were chosen surrounding buildings located inside the known horizontal extent of the groundwater plume to characterize the extent of any associated soil gas plumes (Figure 4).

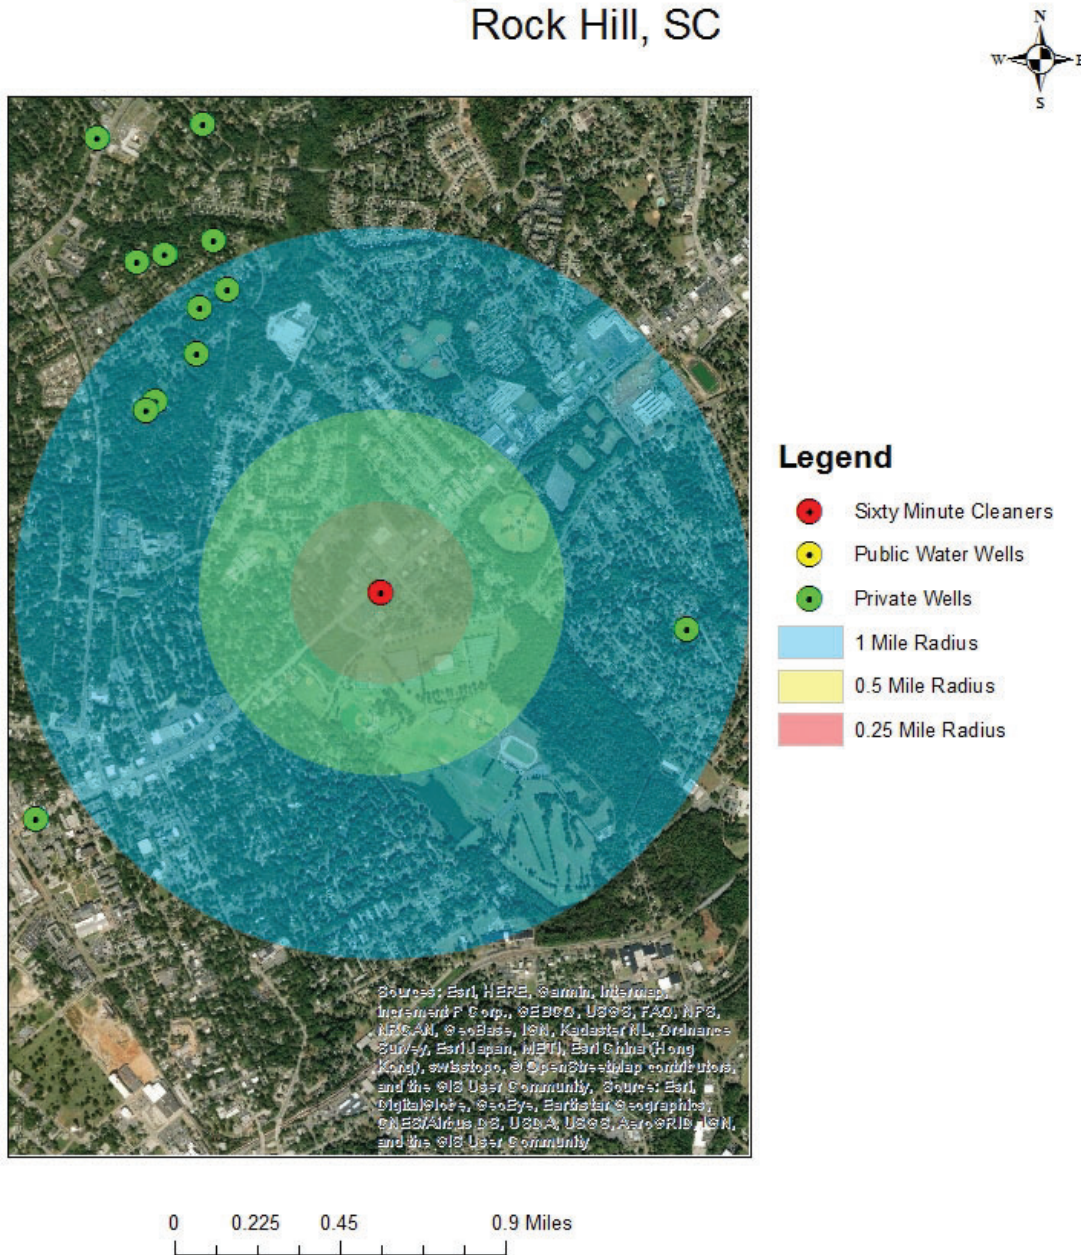
Figure 5
Nearby Public & Private Water Usage
Sixty Minute Cleaners
Rock Hill, SC

There are approximately six private water drinking wells within a one-mile radius of the site. One of the wells is located east of the site. Five of the wells are located northwest of the site (Reference #11). None of the private wells are in the north-northeastern path of the groundwater plume

associated with the former Sixty Minute Cleaners site. There are no public water supply wells within a one-mile radius of the site. (Figure 5) (Reference #11).

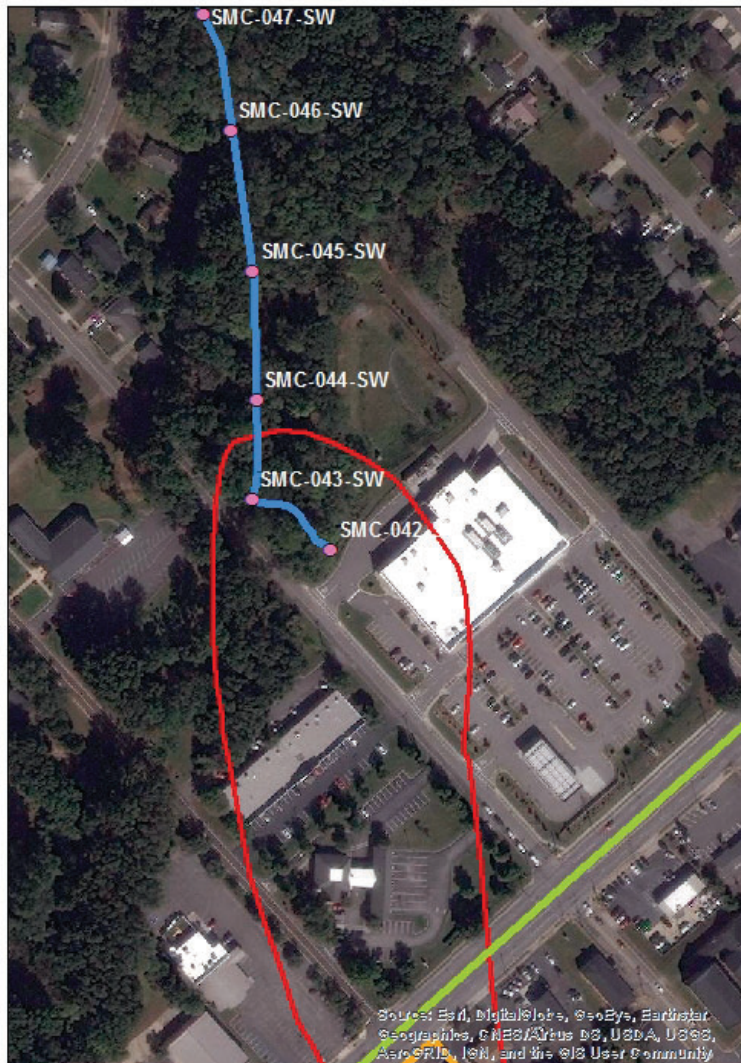
Figure 7
Surface Water Sampling Locations
Site Investigation
Sixty Minute Cleaners
Rock Hill, SC

The location of the stream was originally determined during a site-recon dated December 17, 2019 (Reference C). However, at the time stream samples were collected as part of the SI in July 2020, the upper portion of the stream had disappeared. In July 2020, the stream appeared to originate from underneath Walmart Neighborhood Market property (Appendix C). Proposed sampling locations were altered at the time of sampling to accommodate the new location of the stream (Figure 7).

Six (6) surface water samples were collected as part of the July 2020 field investigation. Figure 7 depicts the location of those samples. Table 2 below summarizes the results.

All samples collected were screened for total chlorinated solvents using the AQR Colortec® method (Reference 10). SMC-042-SW was the furthest upgradient sample collected. This sample was collected from the area that the stream originates under the Wal-Mart Neighborhood Market property (Appendix C). SMC-047-SW was the furthest downgradient sample.

Chlorinated solvents were detected in SMC-042-SW and are present as far downgradient in the stream as SMC-046-SW. No chlorinated solvents were present in SMC-047-SW.

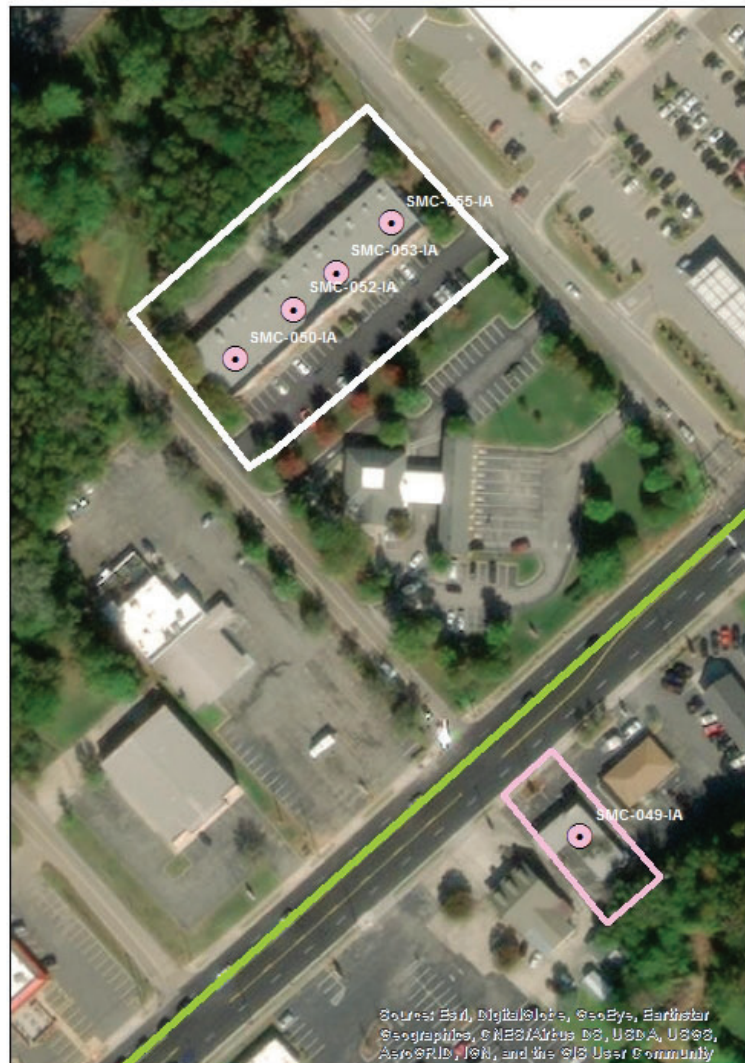
Figure 12
Indoor Air Sample Locations
Site Investigation
Sixty Minute Cleaners
Rock Hill, SC

PCE and TCE exceeded their respective RSLs in SMC-049-IA. This sample was collected at the location of the former Sixty Minute Cleaners. PCE exceeded its RSL in SMC-050-IA. This sample was collected in the Southpaw screen printing business / sales office. PCE exceeded its RSL in SMC-052-IA. This sample was collected in the subunit within Royal Plaza which is currently an empty office space.

The indoor air exceedances in SMC-049-IA and SMC-052-IA are presumed to be caused by the intrusion of soil gas vapors from the existing chlorinated solvent groundwater plume associated with the Sixty Minute Cleaners site. The concentration of PCE found in SMC-050-IA is greater than 19 times its respective RSL. There is a possibility that the indoor air contamination in the Southpaw Screen Printing business / sales office could be caused by the use of PCE/TCE at that facility. The list of chemicals used by the facility and their associated Safety Data Sheets has been requested but was unavailable for this report.
